Impact of Raw Water Characteristics on Aski - Mosul Water Treatment Plant

ABSTRACT

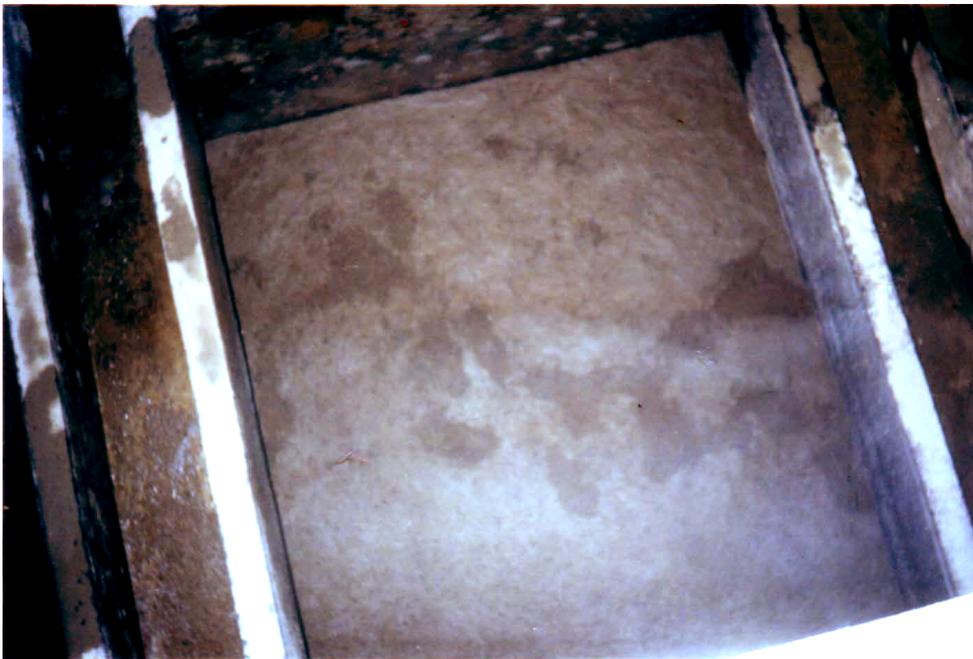
Mounds or holes suggest a lack of uniformity in the gravel and underdrain such as displaced gravel or blocked or broken nozzles.

Mud balls are clumps of sand grain cemented together by deposits. Mud ball and other heavy impurities formed during filtration would drop down to the gravel under layer when the bed was expanded rather than being washed out in the overflow. They are indicators of poor backwash. These problems can easily be detected in the studied filters. plate 1 and 2 display this fact.

Plate 1: Mounds and Holes in the Filter Bed Suggest Probability of Problems in the Gravel and Under Drains.

Accordingly, the existing system of sand layers and underdrains should be substituted by a new one conforming to authorized recommendations. The new system is preferably assumes the following size and thickness (tables 2 and 3) (WHO, 1969) .

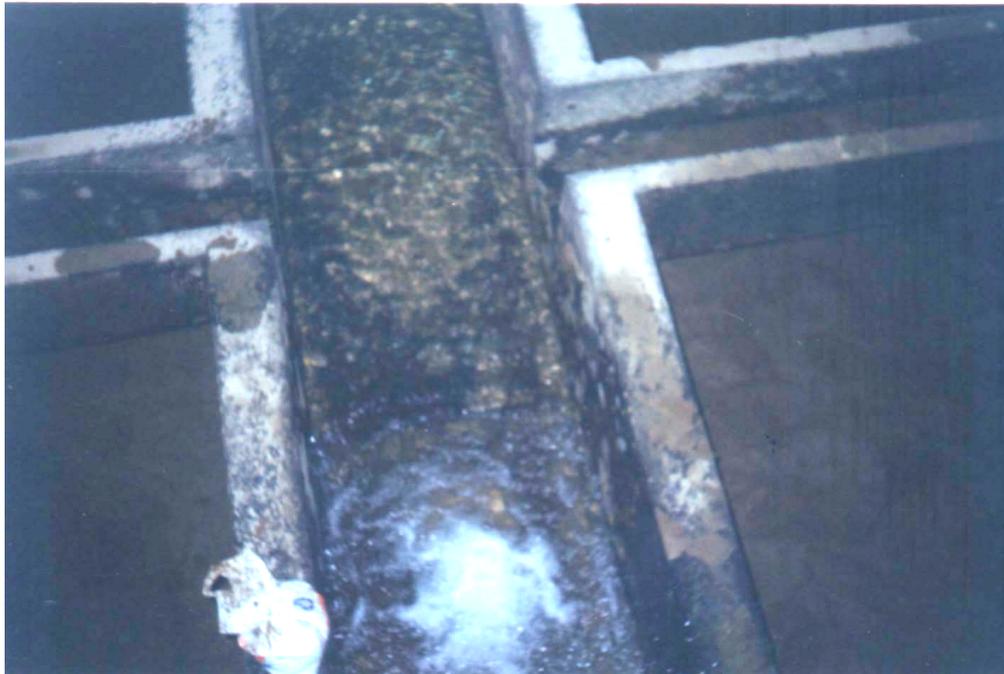
Filters are washed to restore their capacity when the effluent quality becomes unacceptable, or when the pressure drop through the filter reaches a predetermined value. Those two conditions are not followed in the studied filters. Lack of instrumentation for quality determination, and absence of headloss measurements have led to this situation. Back washing is practiced in the plant as a rule of thumb, each 3 days. Besides backwash is practiced for the past 20 years by air scouring only. This inevitably will lead to a lot of problems.

Filters may suffer poor cleaning during hydraulic backwash. Higher backwash rates may also result in disturbance of the graded gravel underdrain, or in carryover of sand in the wash water.

Plate 2: Sand in the Wash Water Trough is an Indication of the Escape of this Material Due to Excessive Air Scour.

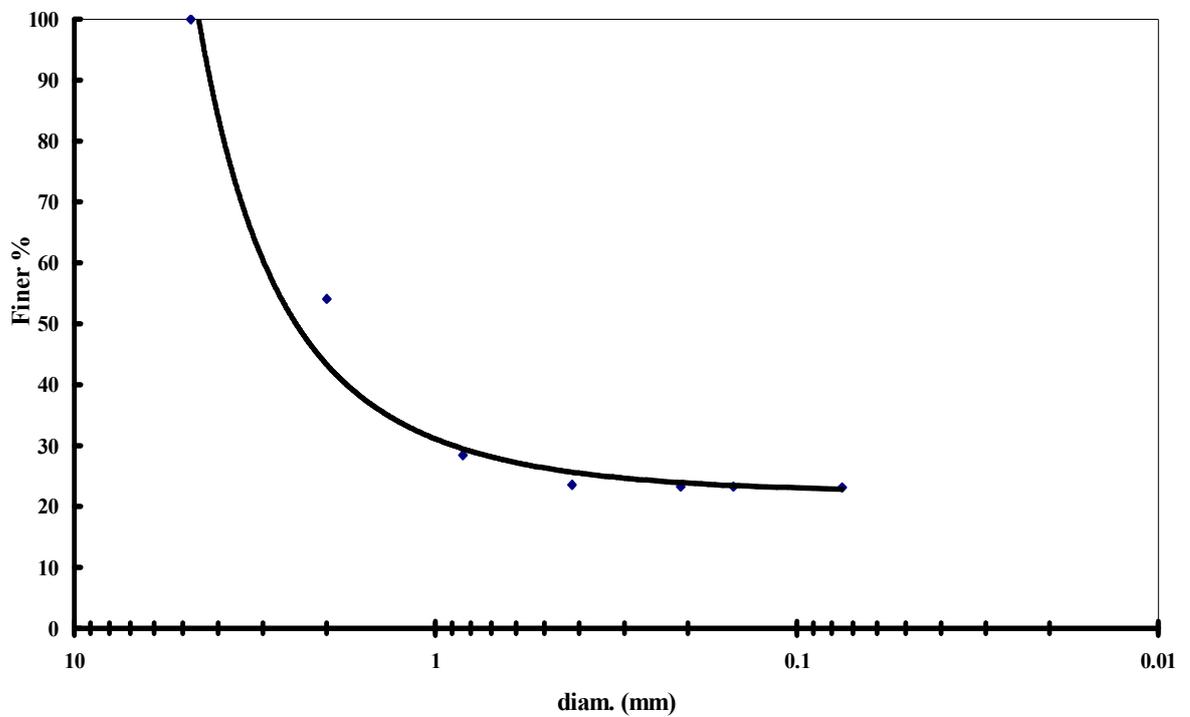
As shown in fig.1 , it is impossible to determine the value of d_{10} as most or all the fines had been washed out due to backwash by air scour.

Besides, an important factor of suitability of sand material to act as a filtration medium is its acid loss in a strong acid. The determined value for the used sand was 6.3% compared to 2.% required by specification (Degremont, 1991).

Fig. 1: Gradation of Sand Medium Used in the Studied WTP.
